**Hydrographic Survey Associated With The Miss Megan Accident  
West Cote Blanche Bay  
St. Mary Parish, Louisiana**

**CHEVRON USA  
5750 Johnston Street  
Lafayette, Louisiana 70503**

**John Chance Land Surveys, Inc.  
200 Dulles Drive  
Lafayette, Louisiana 70506**

**Project Number 06-0654**

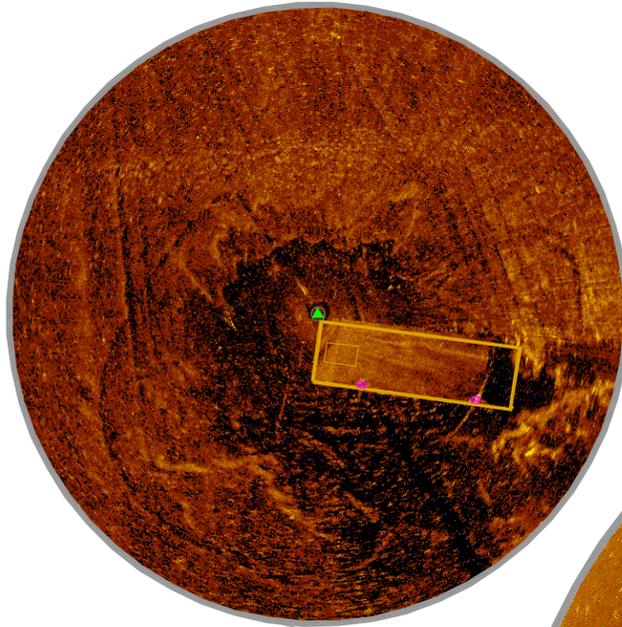
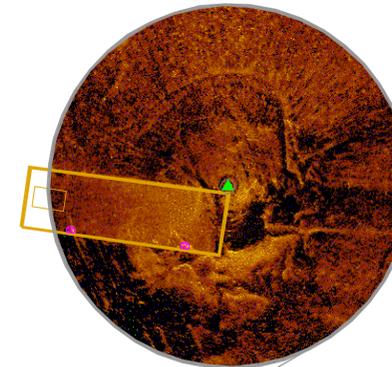
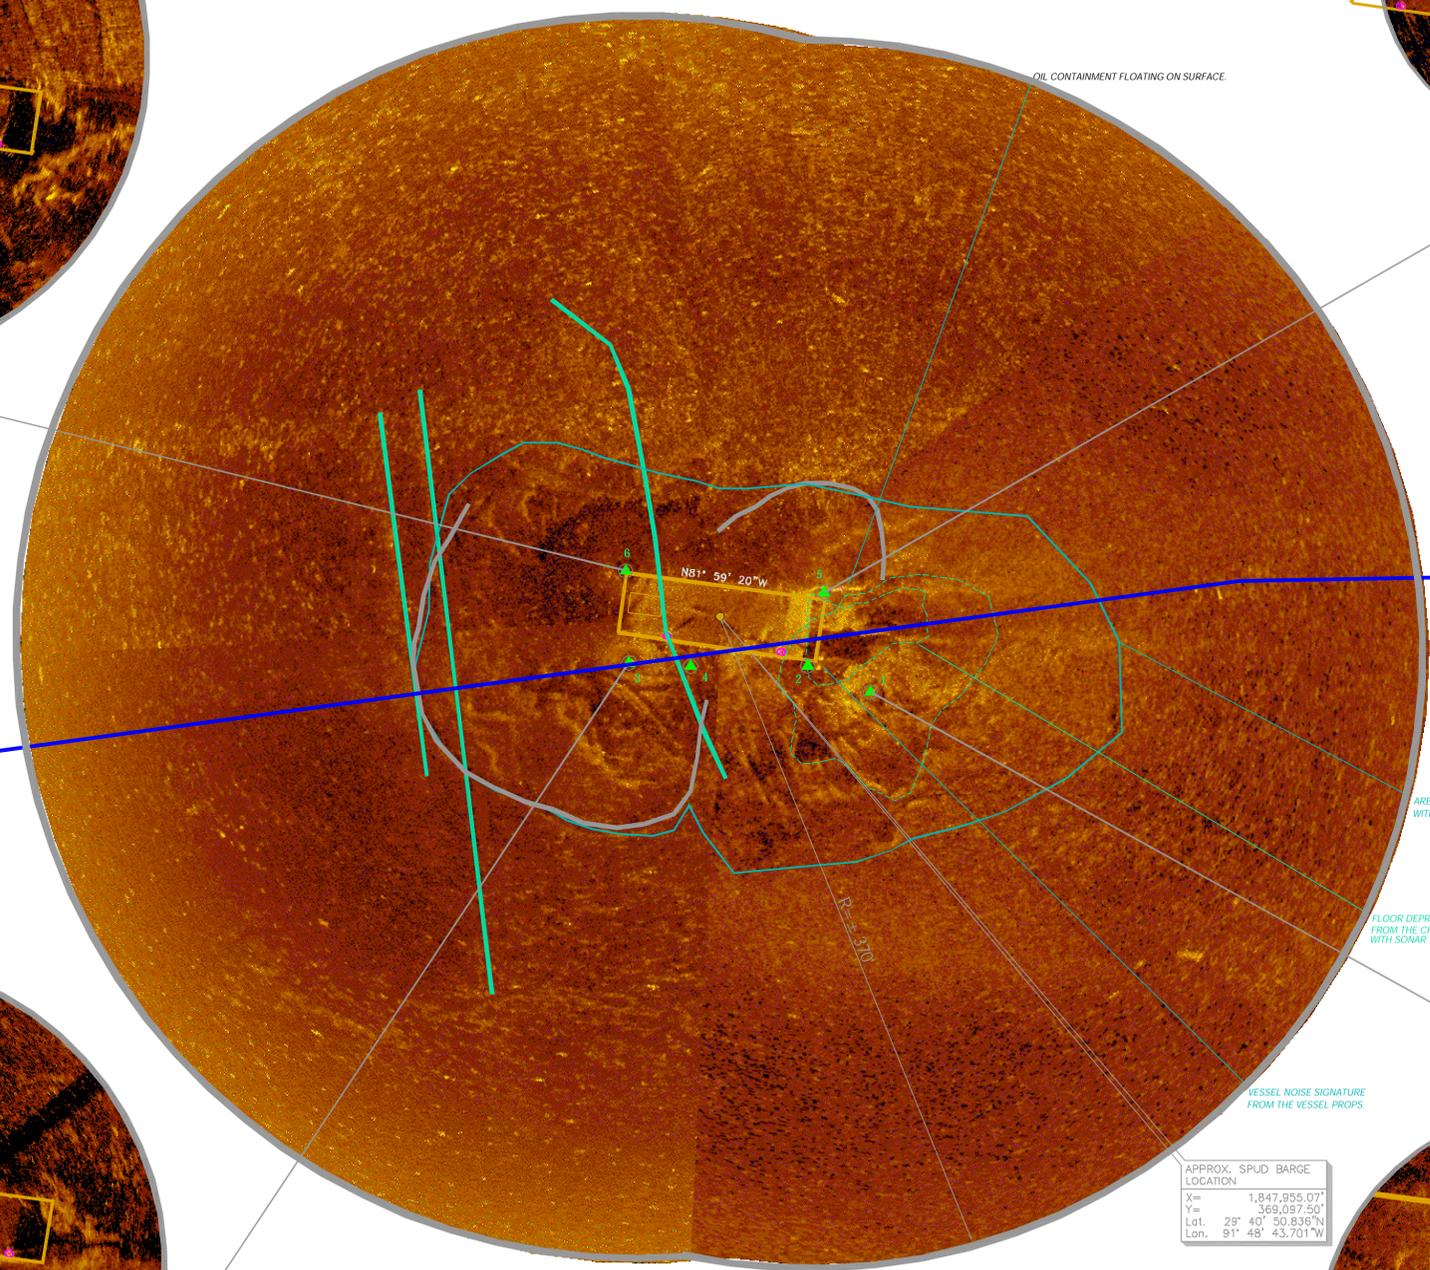
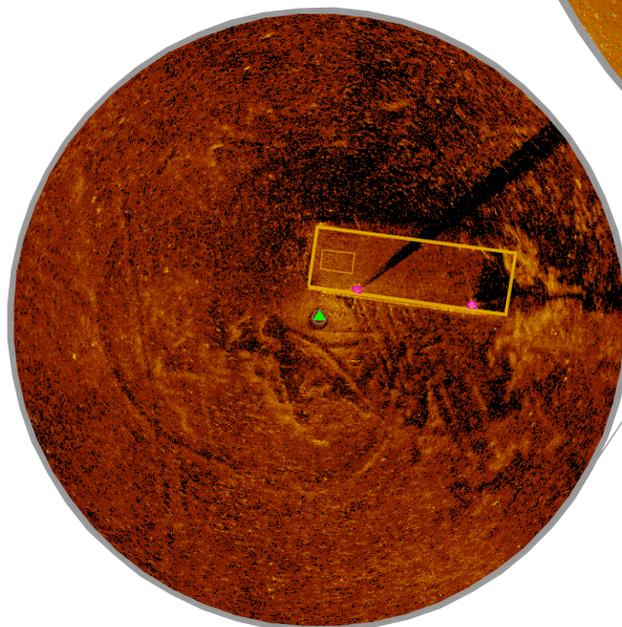
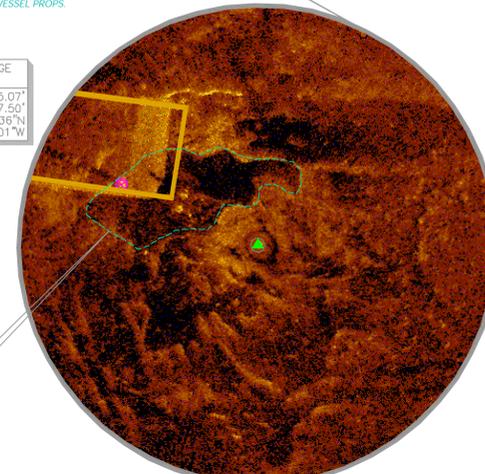
**Figure 2 Scanning Sonar Map**

The preliminary survey consisted of deploying the scanning sonar at six locations around the ATHENA spud barge. The position of each sonar drop is illustrated in Figure 2. This initial image mosaic revealed interesting features, which included a seafloor depression potentially from an explosion and seafloor scarring. Due to the amount seafloor disturbance near the ATHENA spud barge, the significance of the seafloor scarring being associated with the MISS MEGAN or the ATHENA spud barge could not be determined. This information was brought to the October 19, 2006 briefing meeting with agencies and involved parties in Morgan City, LA and the decision to continue with a larger, more comprehensive survey was made.

- NOTE:
- 1) SIZE, POSITION AND ORIENTATION OF SPUD BARGE TAKEN FROM JCLS FIELD DATA DATED 10/17/06.
  - 2) DENOTES SCANNING SONAR DROP LOCATIONS 10/17/03.
  - 3) DENOTES SCANNING SONAR LINEAR FEATURE INDICATING POSSIBLE SPUD BARGE LEGS DRAGGING ON TO THE FLOOR.
  - 4) DENOTES SCANNING SONAR LINEAR FEATURE SIGNATURES.

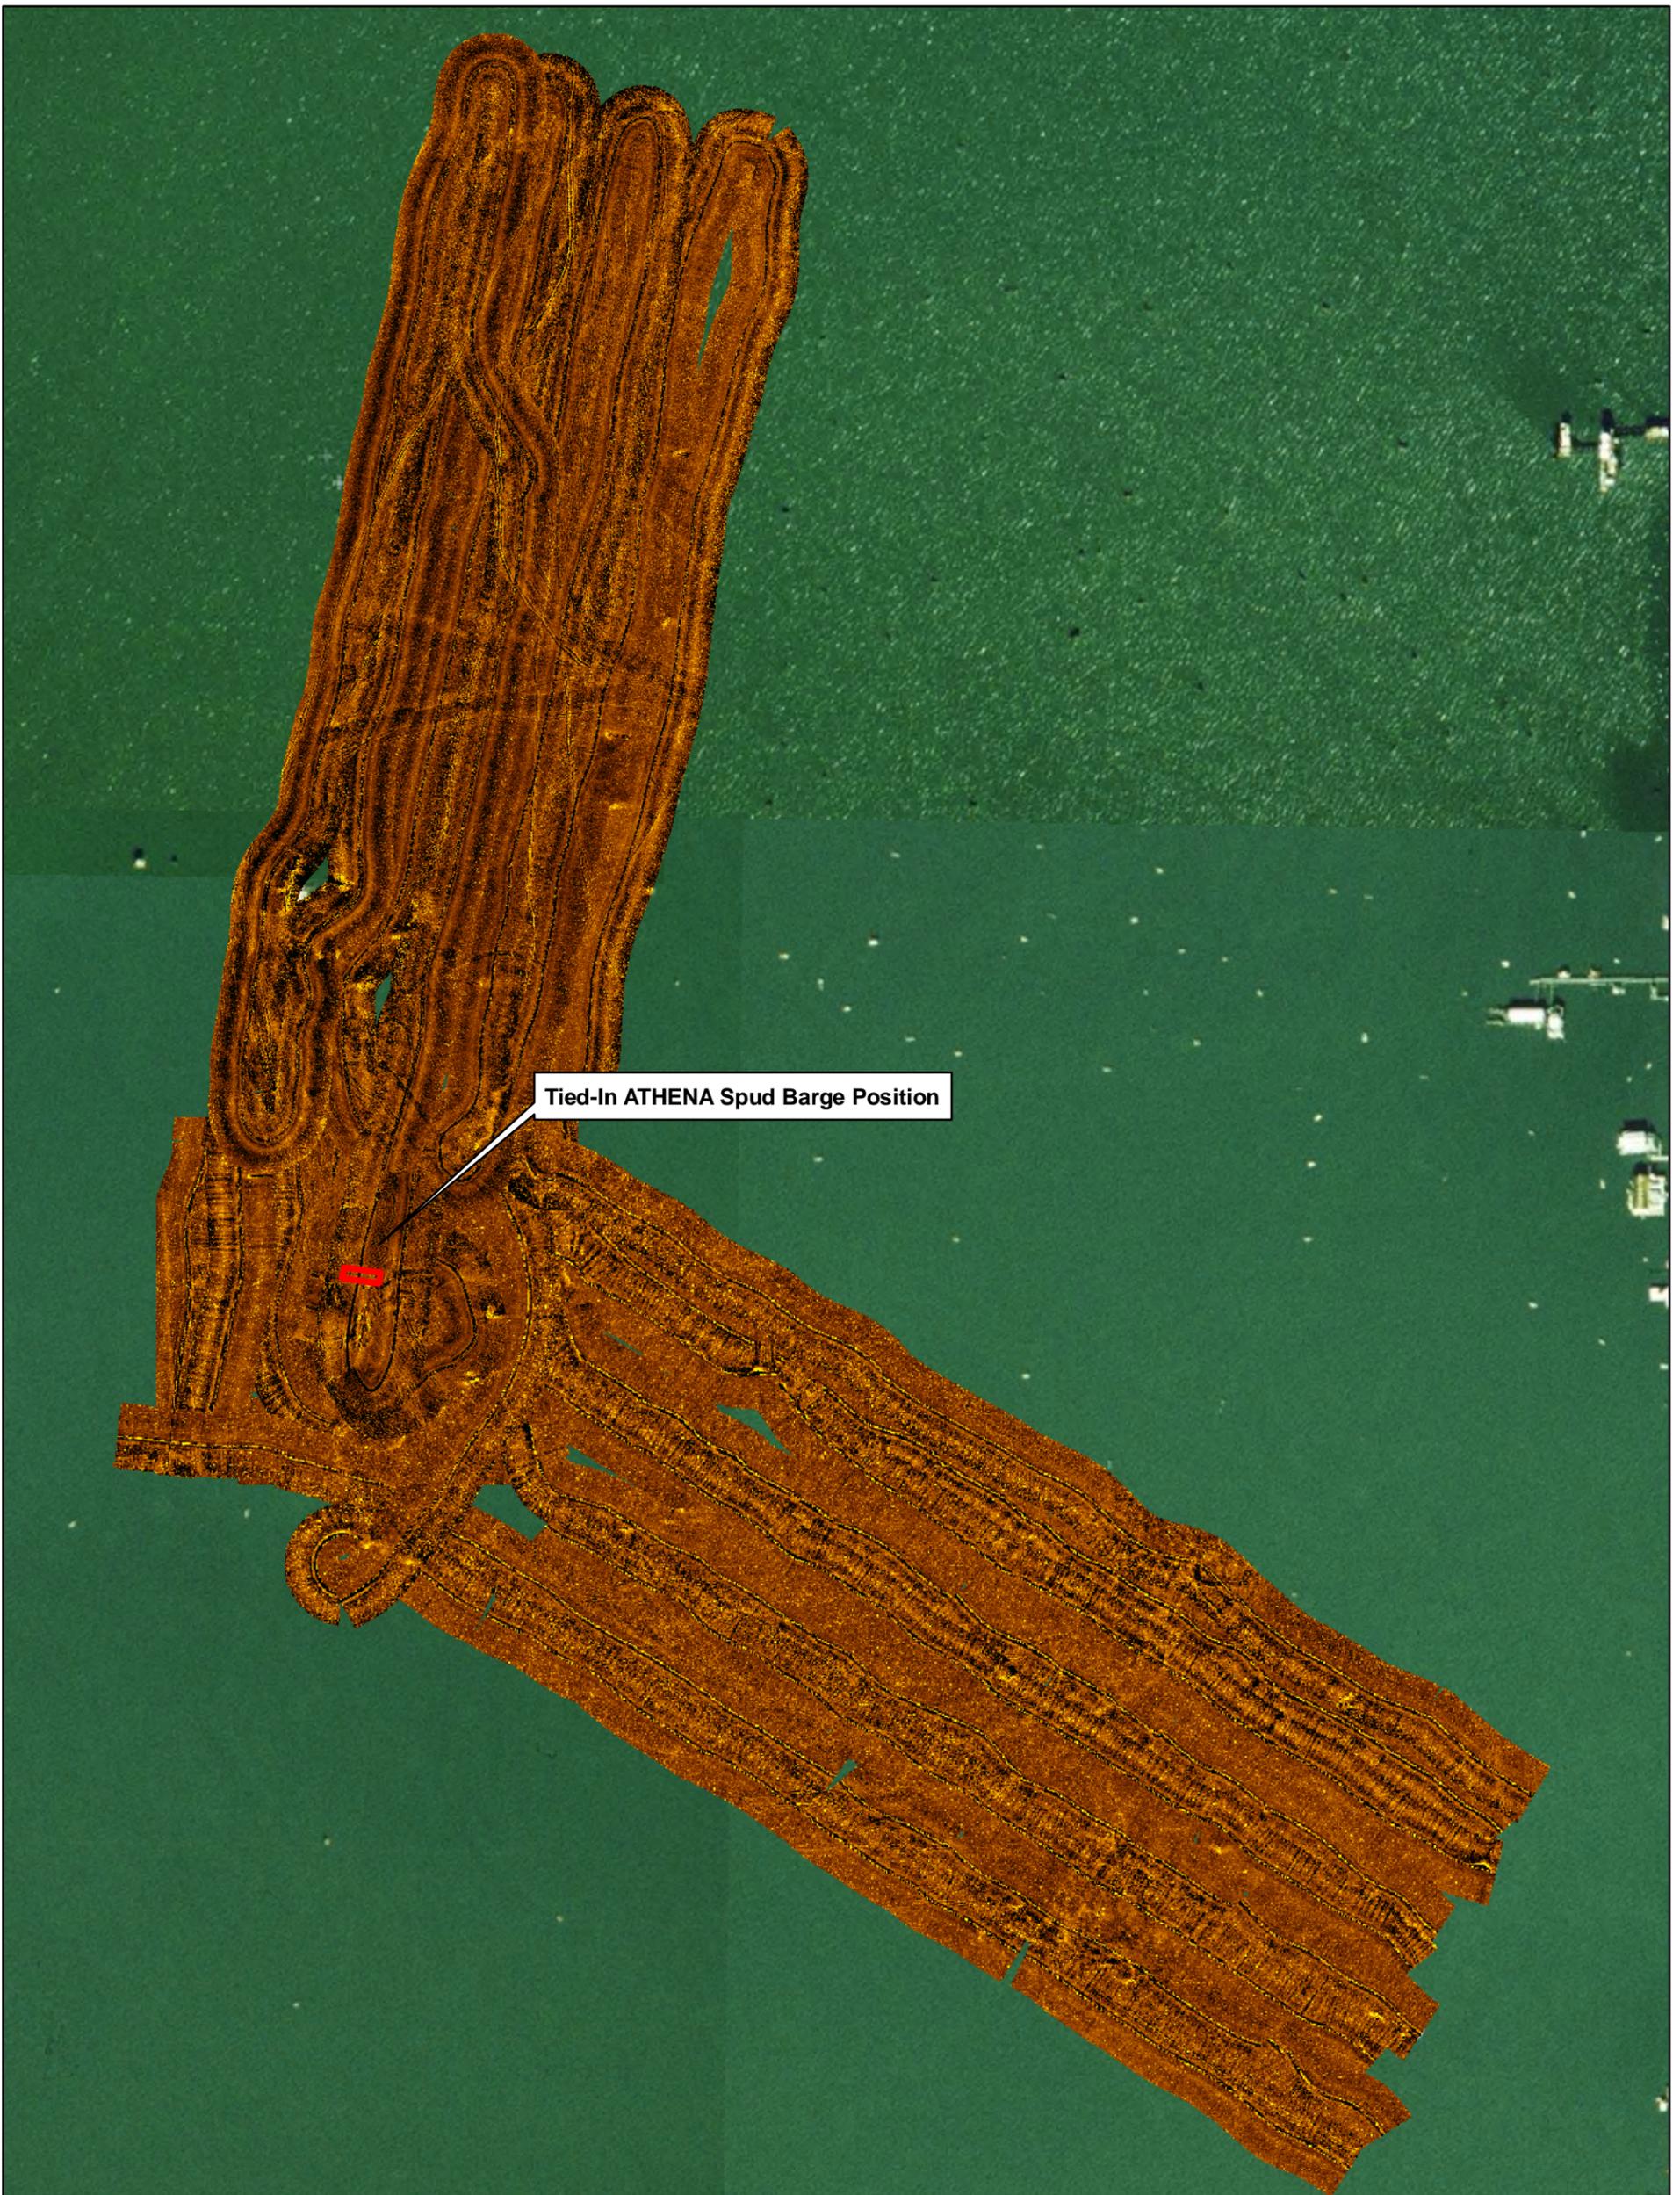
**Figure 3 Sonar Base Map**

The comprehensive hydrographic survey consisted of three areas, which were side-scanned. The first area investigated was at the scene of the accident while the ATHENA spud barge was in place (500' radius from the barge). The second area scanned was between the location of the accident out towards Tank Battery No. 3 (1400' wide by 3800' long). This section scanned was determined by backtracking the route that the MISS MEGAN had taken prior to the accident. No AIS tracking information was available for this route surveyed. The third area scanned was from the location of the accident along a given AIS track (1100' wide by 3500' long). Side-scan sonar imagery for the area surveyed is indicated in Figure 3.

FIGURE 3 - Side-Scan Sonar Coverage Map  
West Cote Blanche Bay  
St. Mary Parish, Louisiana

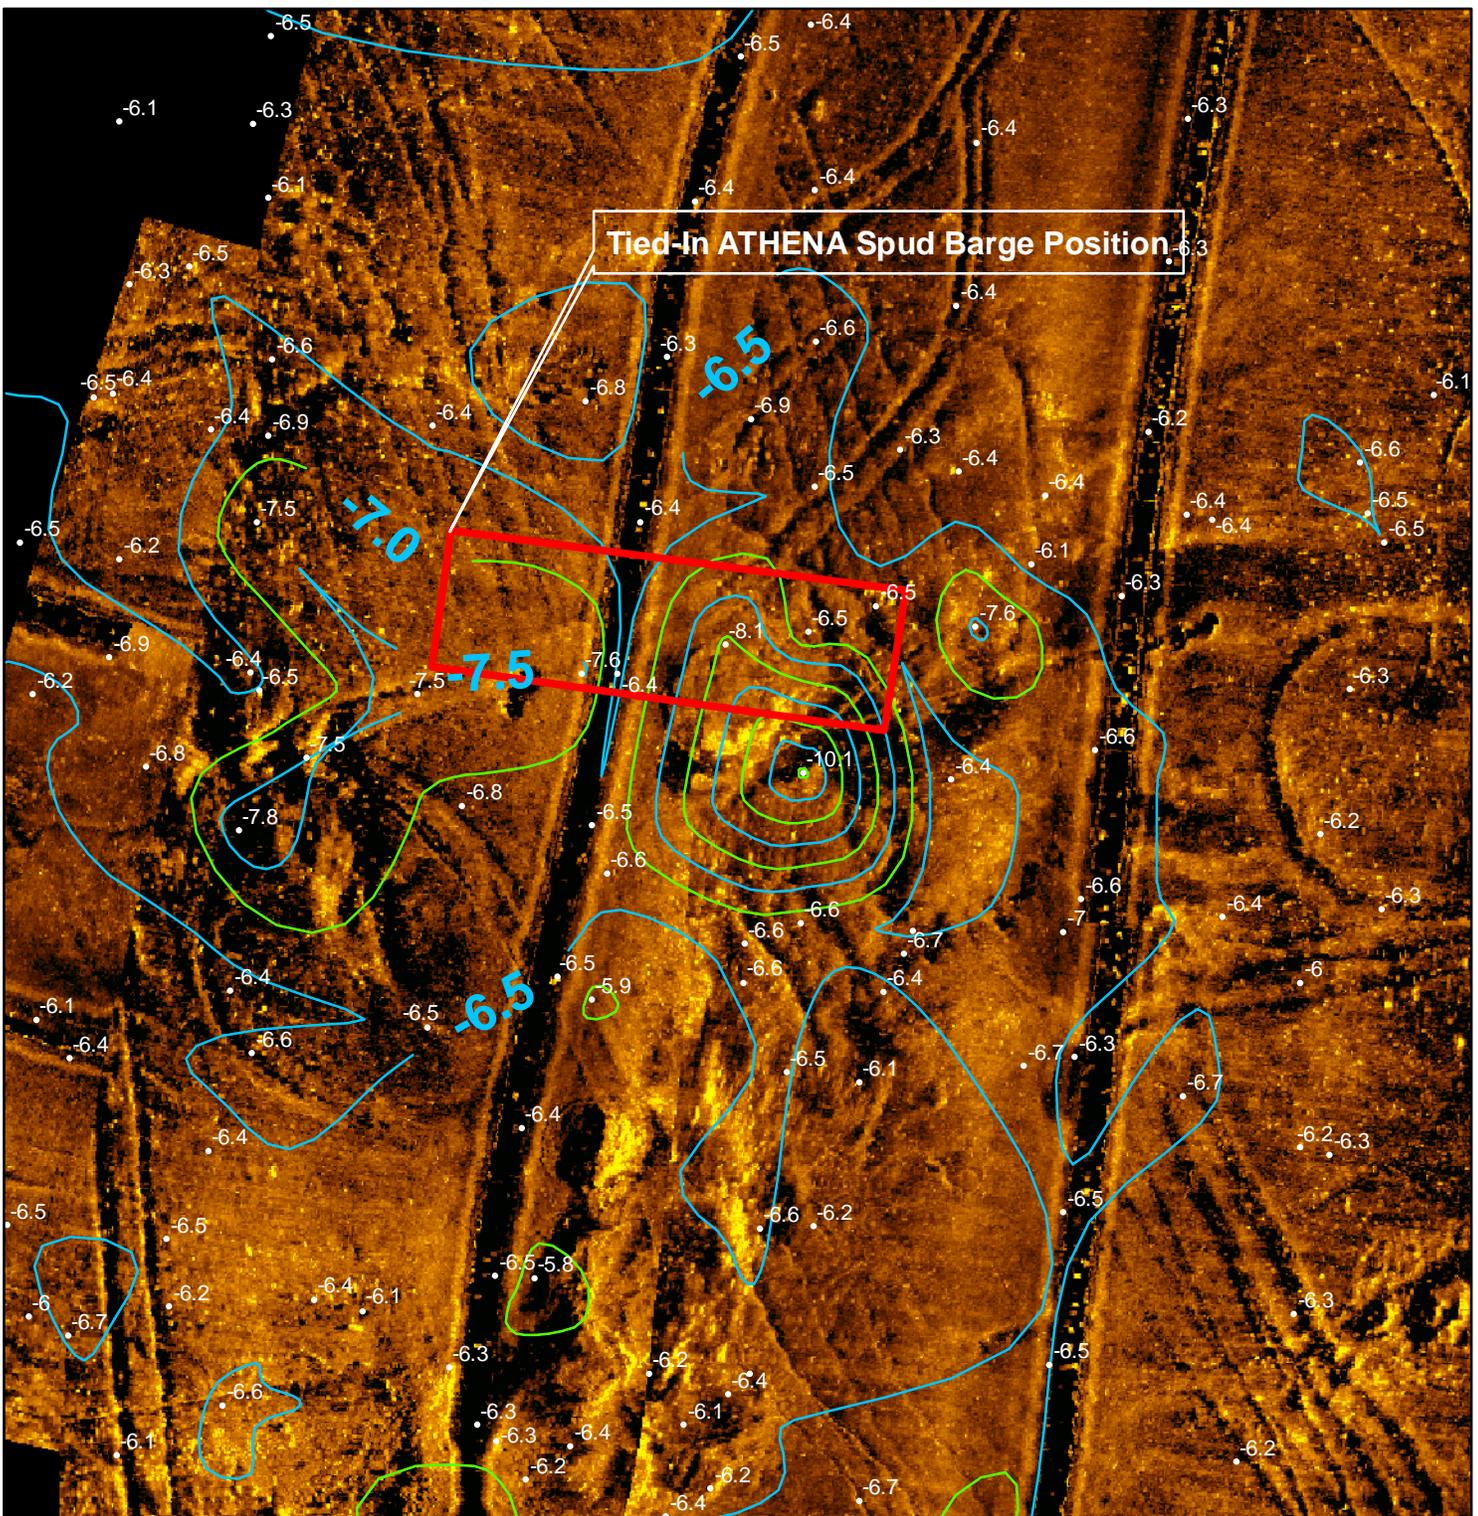
**Figure 4 Bathymetry Map**

The results of the data collected using the single beam echosounder indicate that the tide corrected MLLW water depths in the vicinity of the accident range between 6 feet to 7 feet. In response to a request from the NTSB, Figure 4 was generated.

FIGURE 4 - Bathymetry Contour Map  
West Cote Blanche Bay  
St. Mary Parish, Louisiana

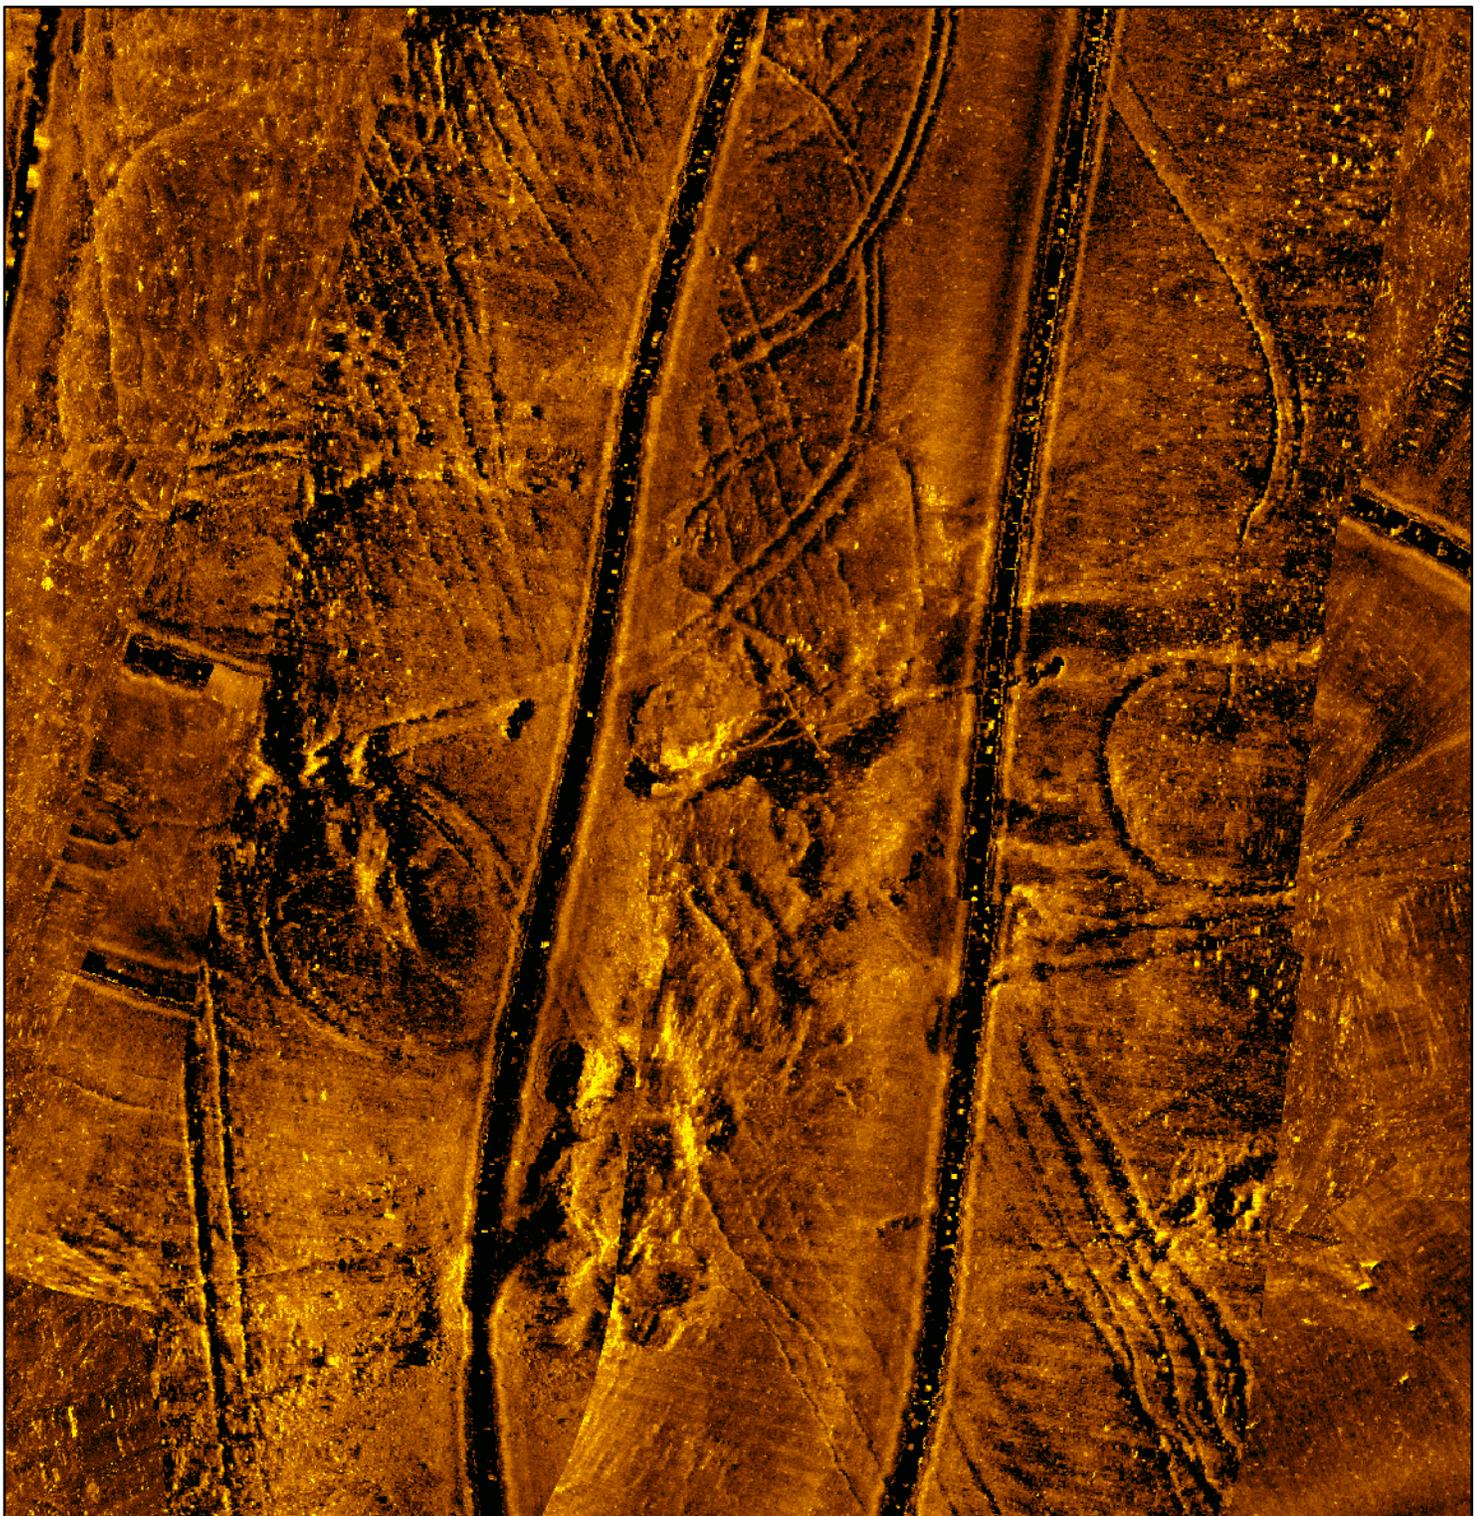
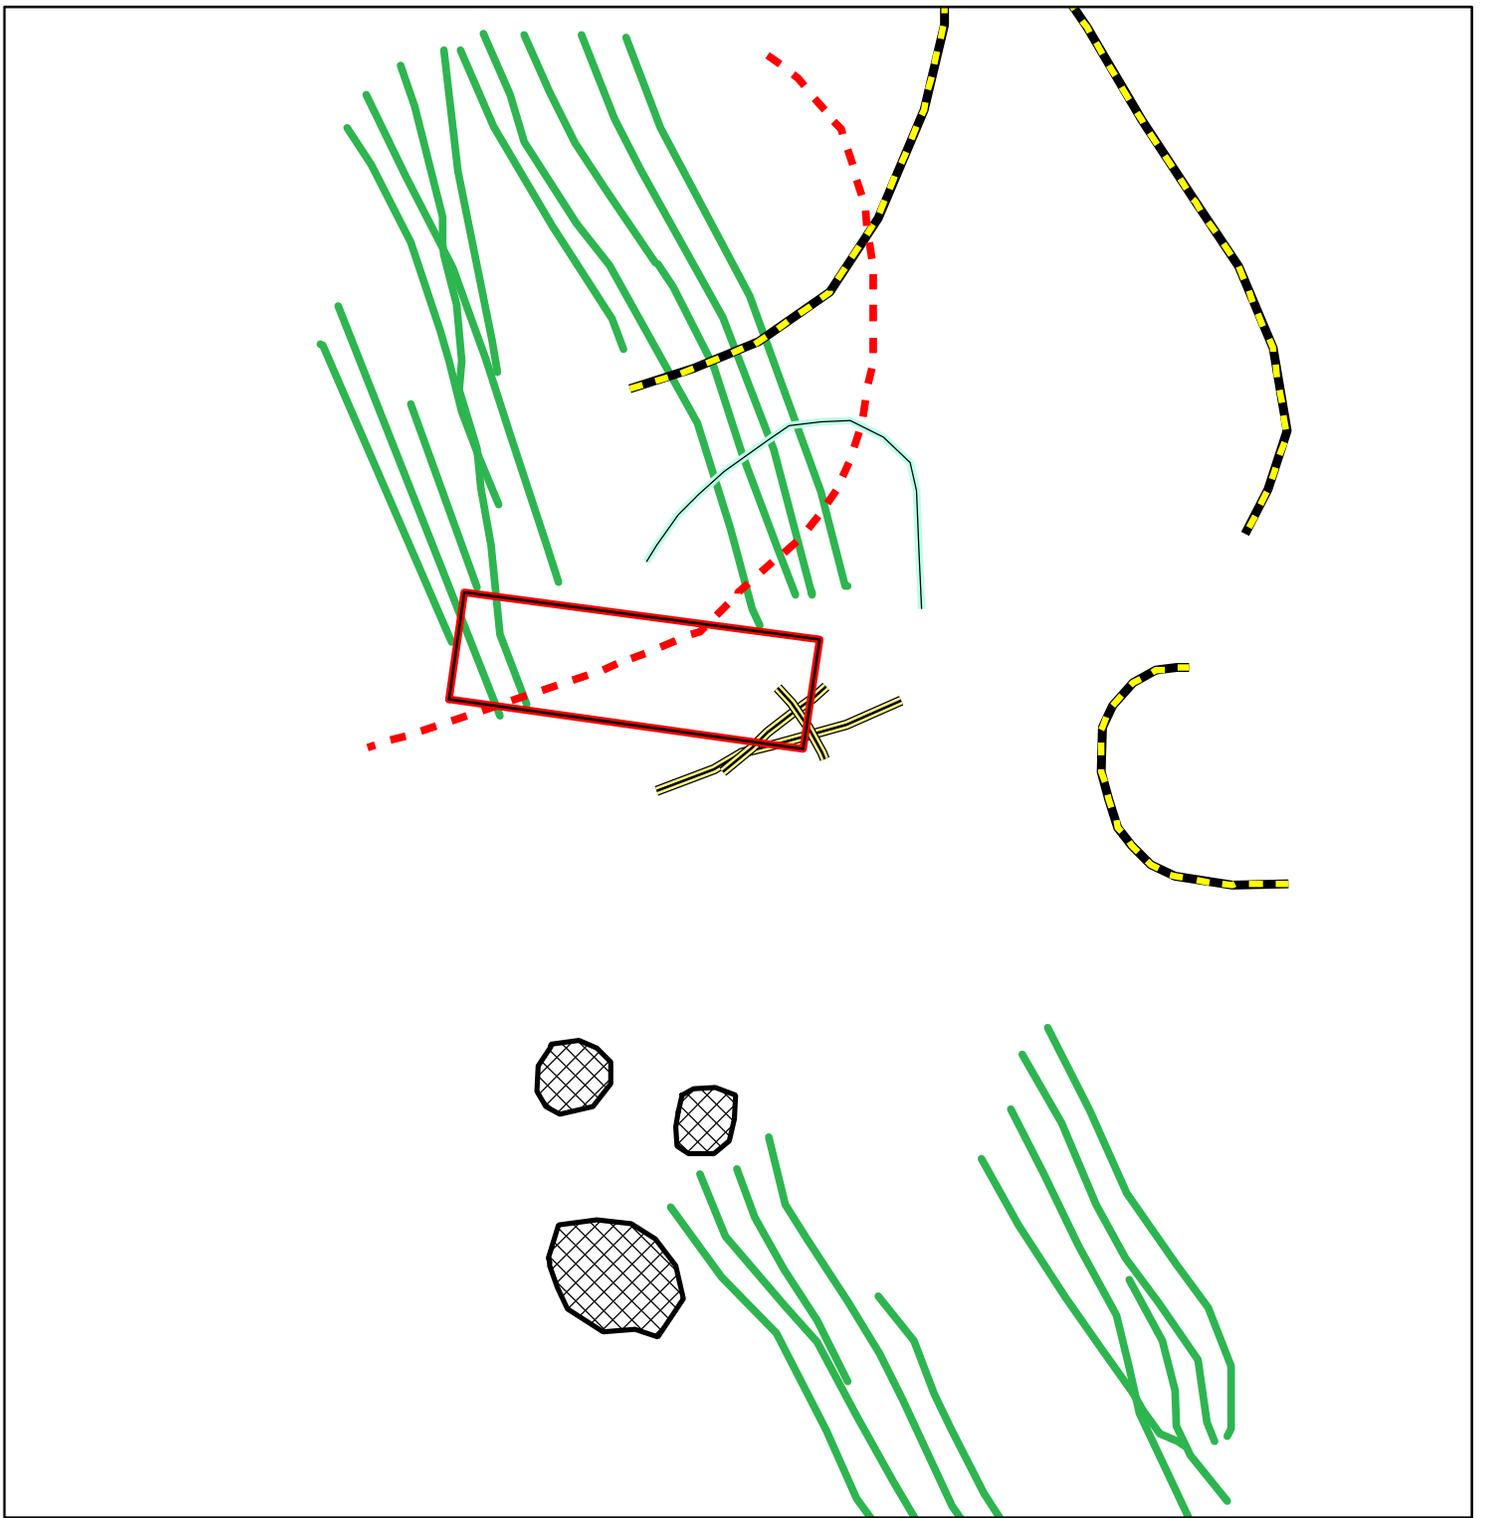
**Figure 5 Sonar Detail**

Overall, propeller scarring from twin-screw vessels has occurred within the area surveyed. This common scarring appears as pairs of lines in which the spacing does not change when turns are made (Figure 5). Please note that the two dark wide lines that run north/south are the sonar nadir. The nadir is the area directly below the side-scan sonar towfish in which void of data. At the scene of the accident specifically where the pipeline was ruptured, a depression in the seafloor has been formed. This circular depression is approximately 3.5 to 4.0 feet lower in elevation than that of the normal seafloor elevation, which is probably a result from the explosion, can be identified by the increased contour lines near the tied-in pipeline. Noted within the side-scan imagery, Figure 5, were several sets of parallel scars near the damaged ATHENA spud barge. These northwest/southeast drag marks could possibly be a result of a recovery operation.

FIGURE 5 - Detail of Propeller Scars  
 West Cote Blanche Bay  
 St. Mary Parish, Louisiana

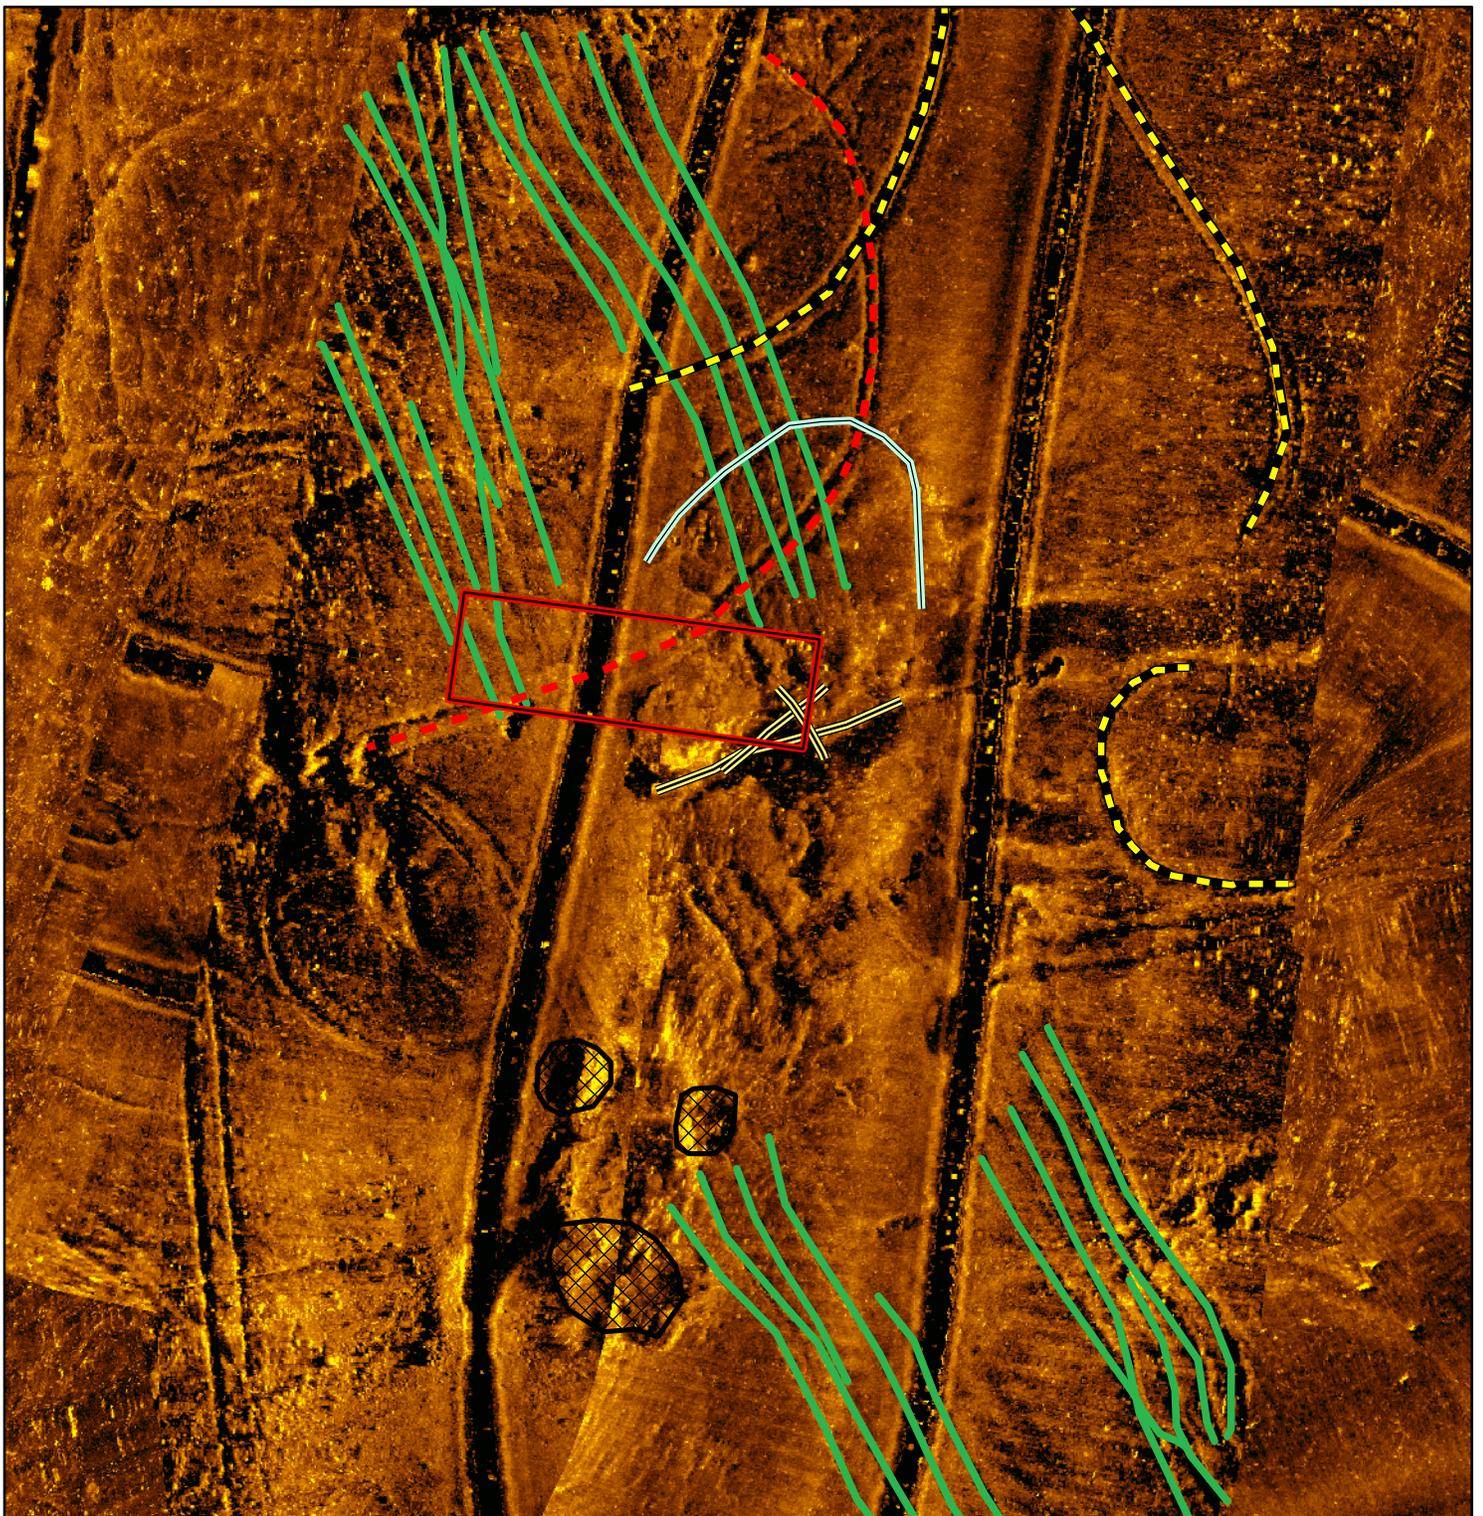
**Figure 5 a Sonar Detail**

FIGURE 5a - Detail of Propeller Scars  
 West Cote Blanche Bay  
 St. Mary Parish, Louisiana

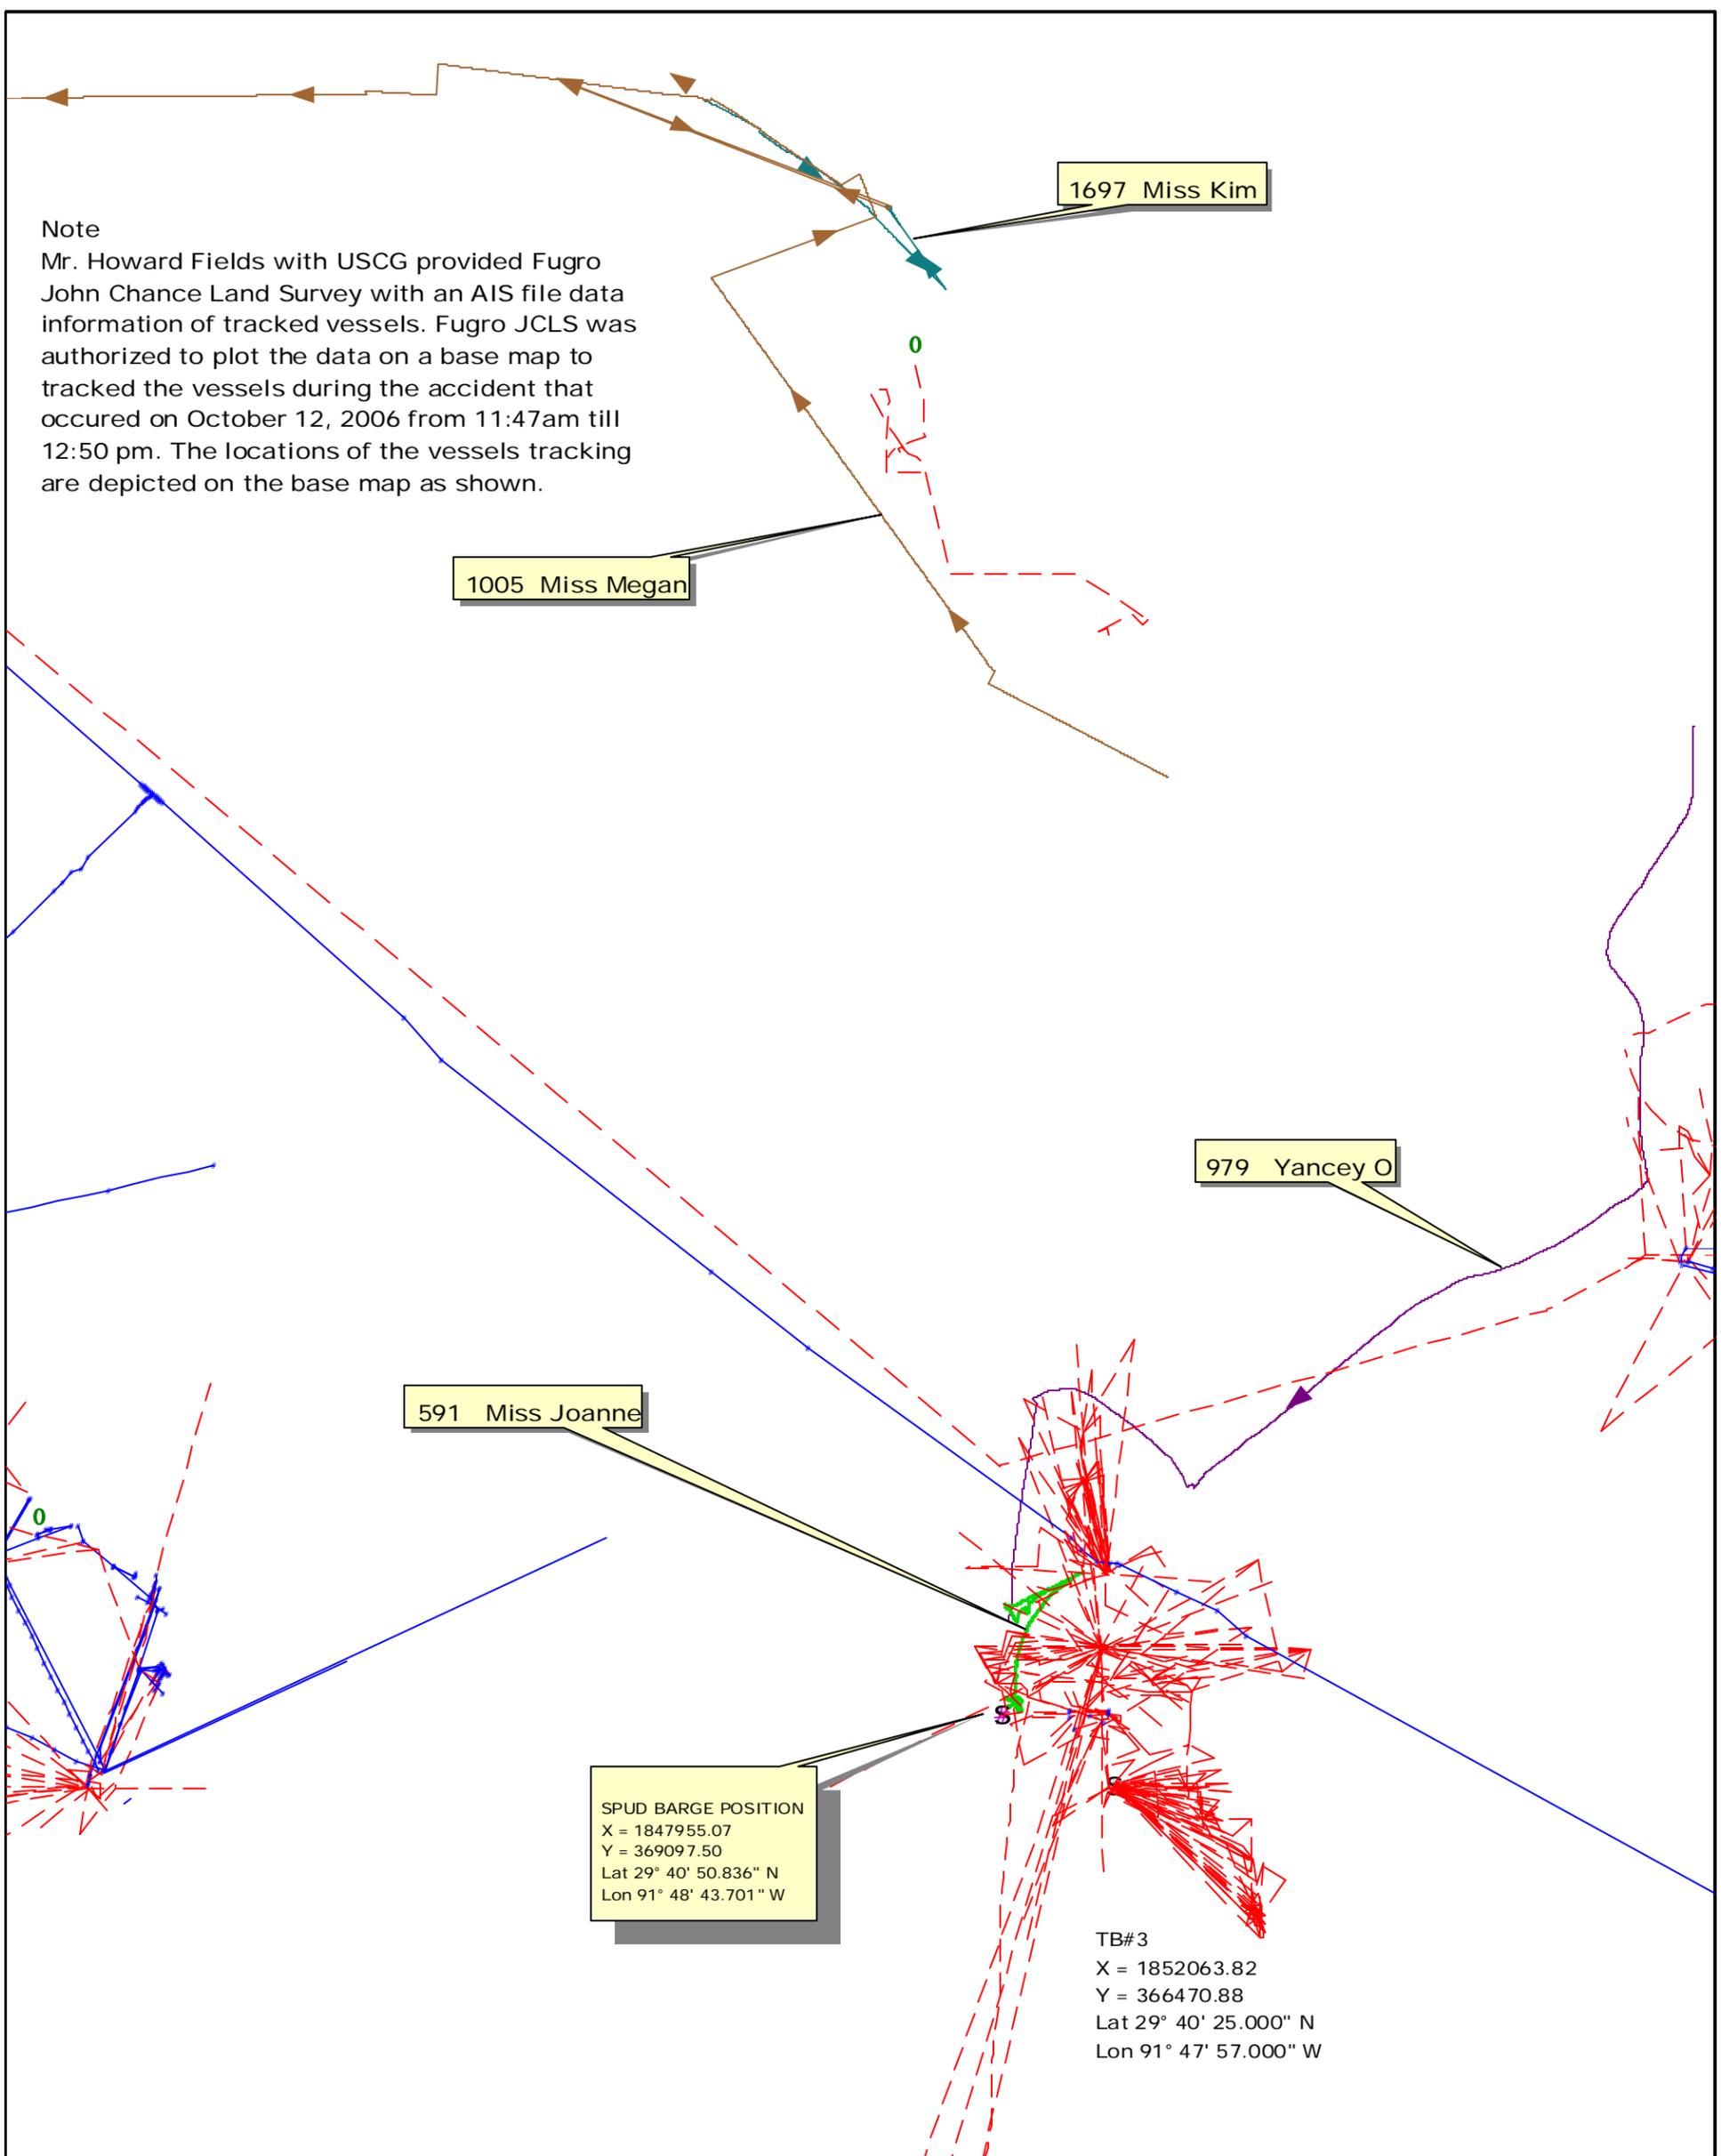
**Figure 6 AIS Base**

Obtained through USCG, the AIS tracking data (Appendix B) during the time that the accident contained no record of the MISS MEGAN at the location of the accident (Figure 6). Although there was a vessel named the MISS MEGAN within the records it was not the MISS MEGAN involved in the accident as stated below:

Note  
 Mr. Howard Fields with USCG provided Fugro John Chance Land Survey with an AIS file data information of tracked vessels. Fugro JCLS was authorized to plot the data on a base map to tracked the vessels during the accident that occurred on October 12, 2006 from 11:47am till 12:50 pm. The locations of the vessels tracking are depicted on the base map as shown.

BASE MAP  
 POST PLOT OF TRACKED VESSELS  
 WEST COTE BLANCHE  
 ST MARY PARISH LOUISIANA  
 Figure #6 Page #12
